WEEKLY SUMMARY REPORT

Client: Needham DPW Dates: 12/9/2019 to 12/13/2019

Contract: Rosemary Lake Dredging

Contractor: Maverick Construction Co., Inc. Inspector(s) on site: Caroline Armstrong

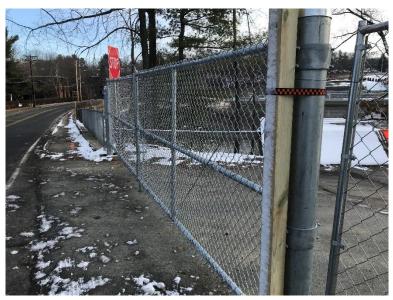
Swing gate installed at Staging Area

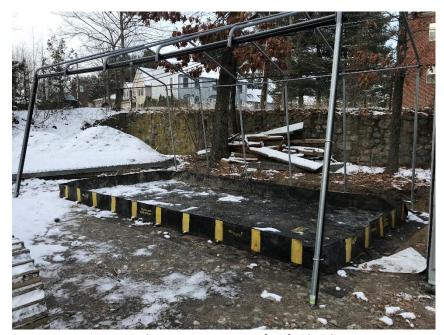
Secondary containment for fuel cube

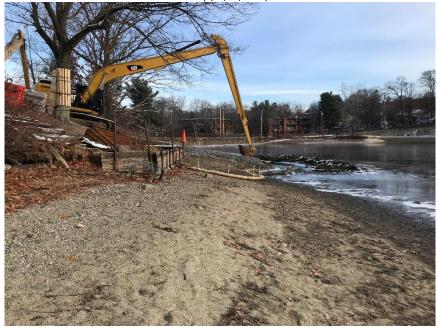
Friday (12/13/2019)

Access Ramp at Staging Area

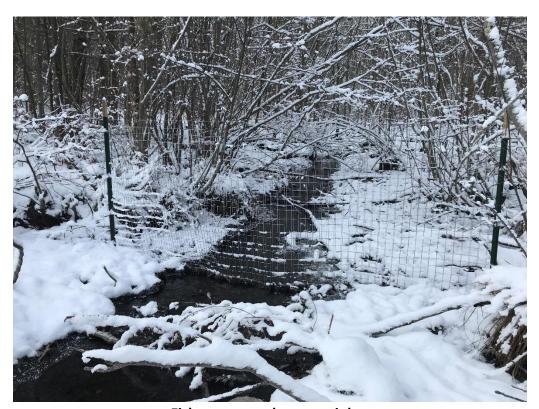
Fish net at southeastern inlet.

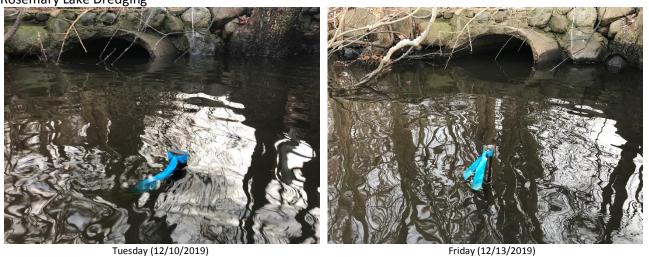
Station 2 (West Street) – Turbidity and sediment depth readings taken on Tuesday and Friday.

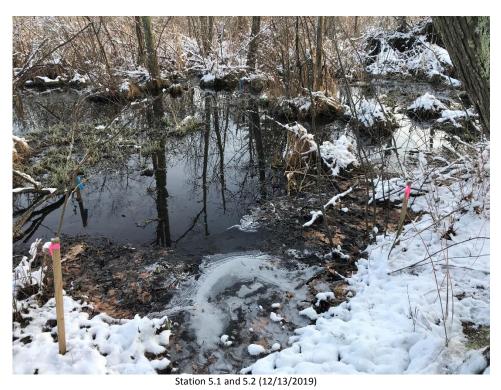
Station 5.1 and 5.2 – Edge of Bank shown. Turbidity and sediment depth readings taken on Friday. Snow occurred on Wednesday.

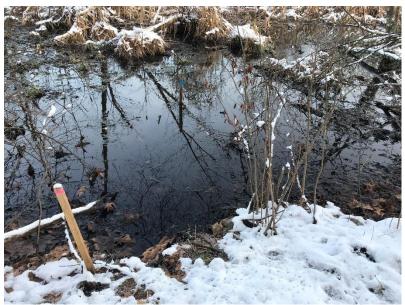
Station 5.3(12/13/2019)

Station 5.3 – Edge of Bank shown. Turbidity and sediment depth readings taken on Friday.

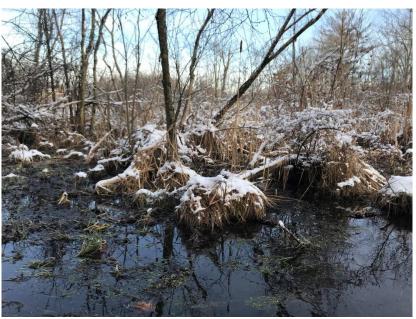
Station 5.3 (12/13/2019)

Station 5.3 - Vegetation at Station 5.3

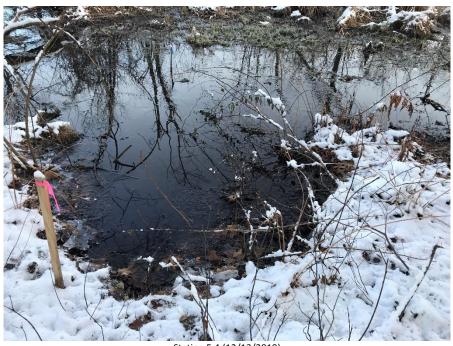
Station 5.4 (12/13/2019)

Station 5.4- Edge of Bank shown. Turbidity and sediment depth readings taken on Friday.
